PEMBROKE DAM

NH 00377

PHASE I INSPECTION REPORT
NATIONAL DAM INSPECTION PROGRAM

MARCH 1979

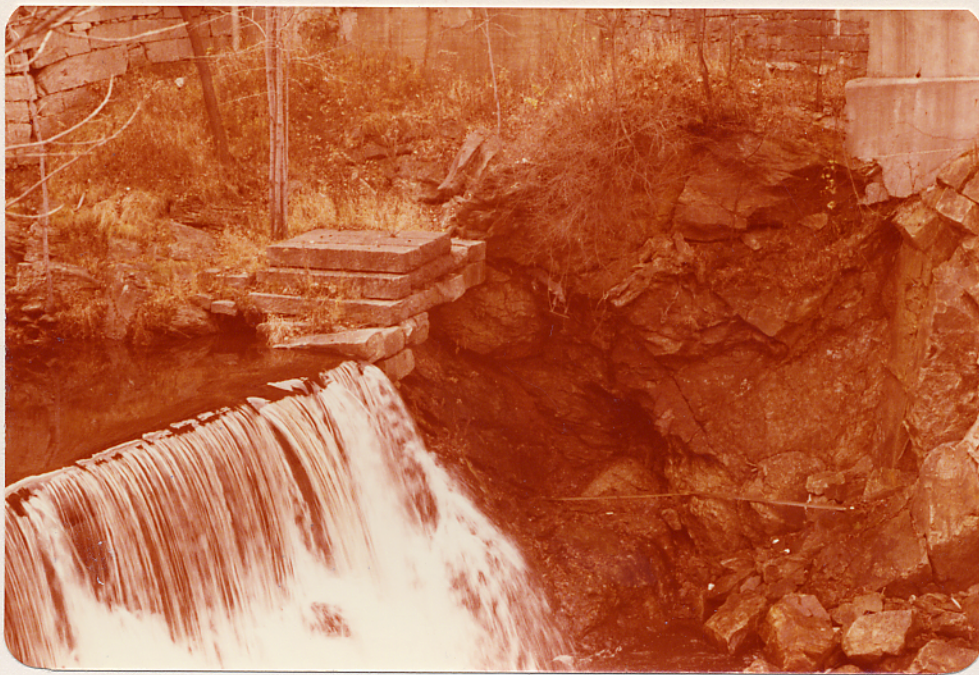
C. Right Training Wall		In good condition with the exception of minor joint erosion at spillway crest elevation
D. Left Abutment		Some erosion of bedrock
OUTLET WORKS

1. View of left abutment from right side
showing erosion of rock

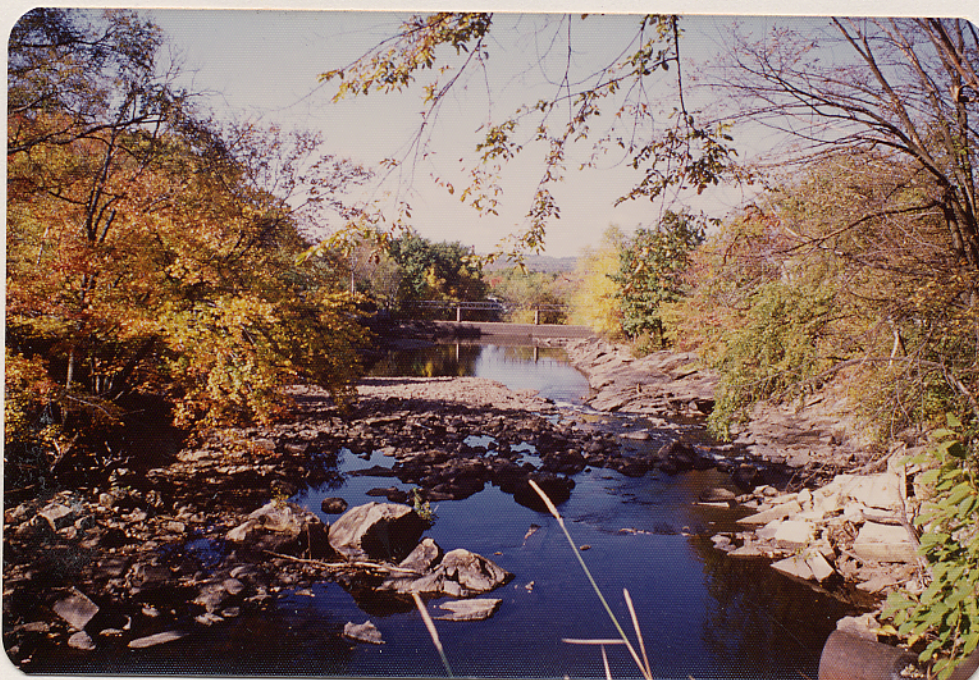
2. View of downstream channel showing
China Dam

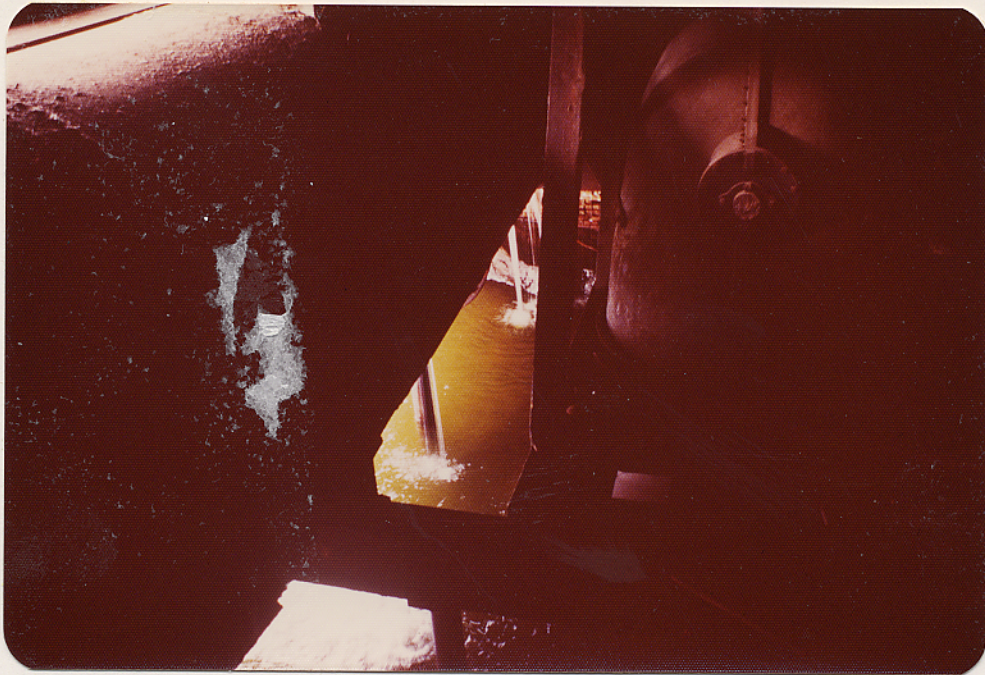
This structure is in poor condition. Observations of the interior of this foundation revealed that seepage at a rate of 5 to 10 gpm was emanating from the corner of the foundation adjacent to the right end of the spillway. Seepage at the approximate rate of 10 to 20 gpm is occurring through the foundation located to the right of the right sluice gate. Seepage through the brick masonry was observed at numerous random locations. The timber sluice gates are partially rotted resulting in a high rate of seepage flowing into the chamber. Standing water is prevalent over the major portion of the base of this chamber.

Some of the columns were founded on the crown of the penstocks which has resulted in permanent deflection of these conduits. It is not known whether this procedure had the approval of the local building inspector or other authority. The forebay wall has been patched with concrete where stones had previously been dislodged.

3. View from inside old mill building showing flow through holes in old penstock

- (1) Evaluate the source of the seepage in the mill foundation and bring the seepage under control.
- (2) Evaluate rehabilitation or sealing the sluice gates and their operating mechanisms.
- (3) Evaluate the foundation support system for the first floor of the building.

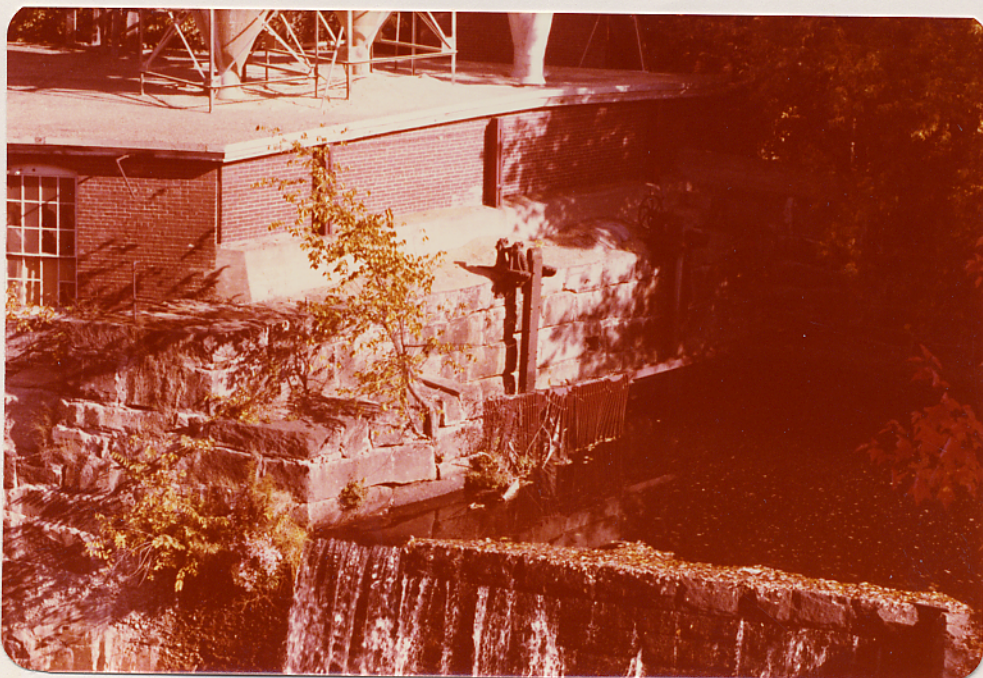
4. View from left side showing old intake for power plant

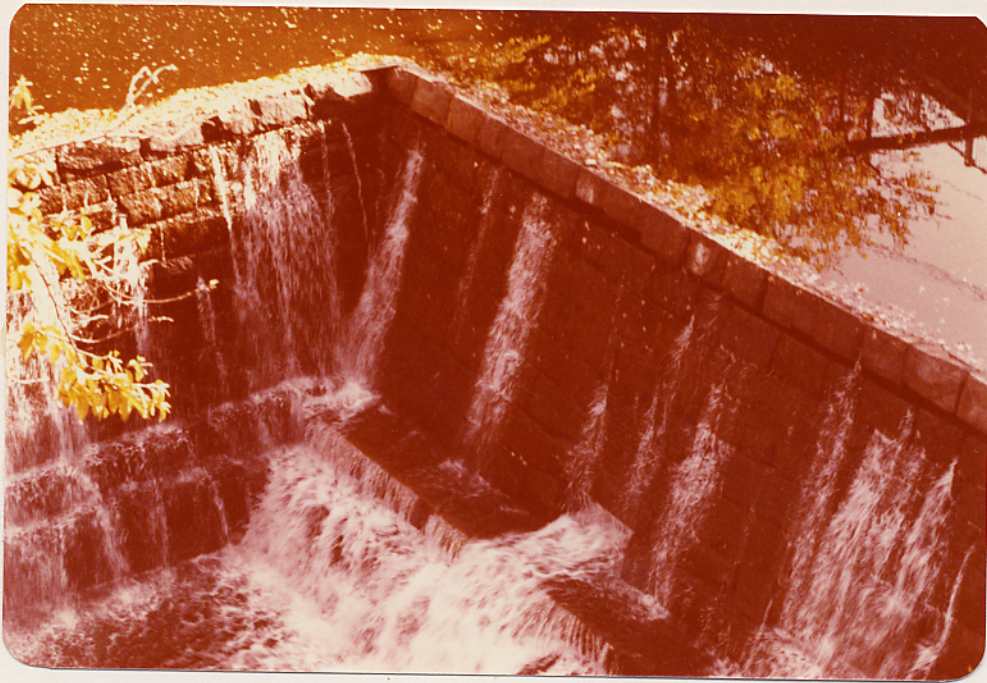
Seepage was observed at numerous locations through the open joints. The outlet tunnel located at the top of the stepped foundation discharges water at approximately 50 gpm. This appears to be a drain outlet, since there is no evidence of a control structure. A bricked up opening approximately 3 feet square is located above the drain outlet. Another bricked up opening approximately 6 feet wide and 8 feet high is located adjacent to the left abutment. There are two courses of squared stone blocks which extend approximately 3 feet above this brick. It is conceivable that this was the location of a former waste gate.

5. View from downstream left side showing leakage through squared stone masonry and unidentified rectangular outlet

The recommended minimum remedial measures for this dam are to place a concrete face on all stone masonry and to bring the seepage through the spillway under control. Also institute a program of annual technical inspections.

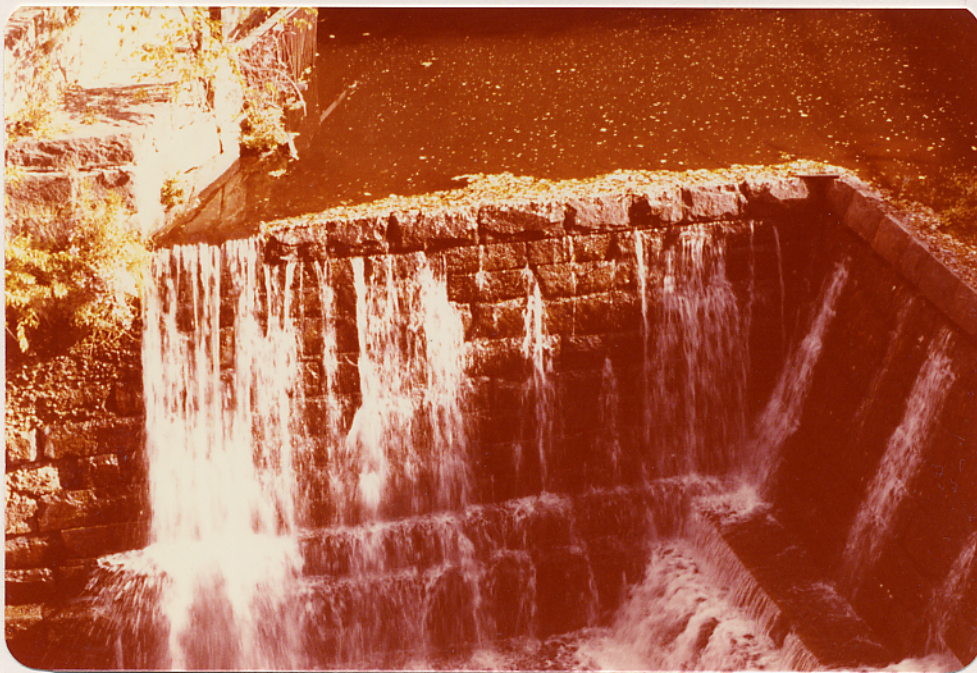
6. Detail of above photo highlighting leakage through dam
